September 1, 2004

Final Report

SERDP Pollution Prevention Project 1137

Non-Destructive Testing of Corrosion Under Coatings

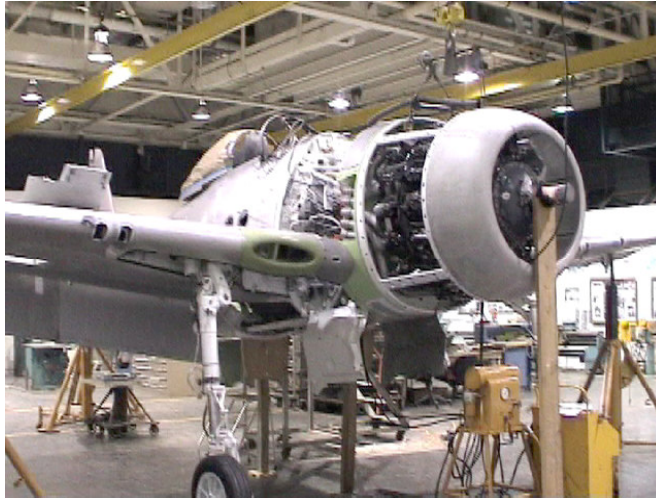
A corrosion survey was conducted on a Grumman-produced WWII aircraft (see Figure 100). This aircraft was produced at the end of WWII and was approximately 50 years old plus is currently under restoration by a number of Grumman retirees in Bethpage, NY. Some of these individuals actually worked on the original Bearcat production aircraft. Much of the aircraft was in the unpainted or bare condition, but a number of components were being refinished and hence were used to test out the IR camera system. Some of these components included environmental ducts, which are shown in Figure 101. The figure shows Dr. Don DiMarzio on the right and John Weir examining the duct for corrosion in real time. The camcorder viewer is being used to observe the IR image of the aluminum duct surface for corrosion under the polyurethane coating. Figure 102 shows the duct up close on a work- bench with an up close shot of the duct in the IR. The IR image shows a darkened/abraded area and weld zones.

Other locations surveyed on the aircraft included the landing gear and the wing structure. Corrosion was observed in both locations. The engine cowls that had been painted were also observed and they had been cleaned of corrosion prior to the application of the primer. This was quite apparent as the sanding and abrasion around fasteners was witnessed under the paint in the real time IR Images taken.

Figure 100 Grumman Bearcat Field Demonstration

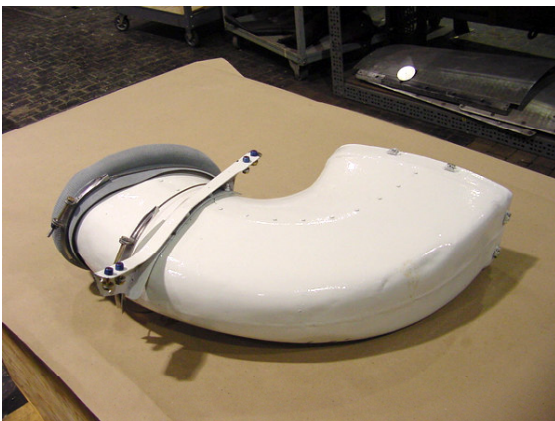
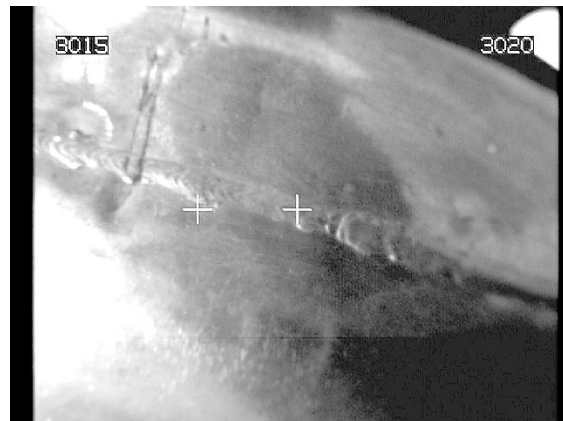
Figure 102 Welded duct from Bearcat. Photograph No. 1 shows white paint and photograph No. 2 shows weld area and corrosion that was reworked/abraded under the painted surface

The photographs in Figure 102 show a typical Bearcat environmental control system (ESC) duct that has been welded in at least two locations, as shown by the lower photograph. As can be seen from the top figure, the duct has been painted and the coating is most likely a coating of primer, MIL-PRF-23377 TYI and a top coated with MIL-PRF-85285TYI Gloss Insignia White Color No.17925. The lower photograph shows the aluminum surface of the ECS duct, which has been most likely abraded, prior to painting. The abraded area is located in the center of the photograph and is a little darker than the surrounding area. These figures were snap shots taken digitally from a movie that was made during the real time corrosion survey. Note: Two movies were made. One of the movies was output from the IR camera feed into the camcorder and the other movie was just the standard illumination feed into the camcorder much the same way a home movie is made.

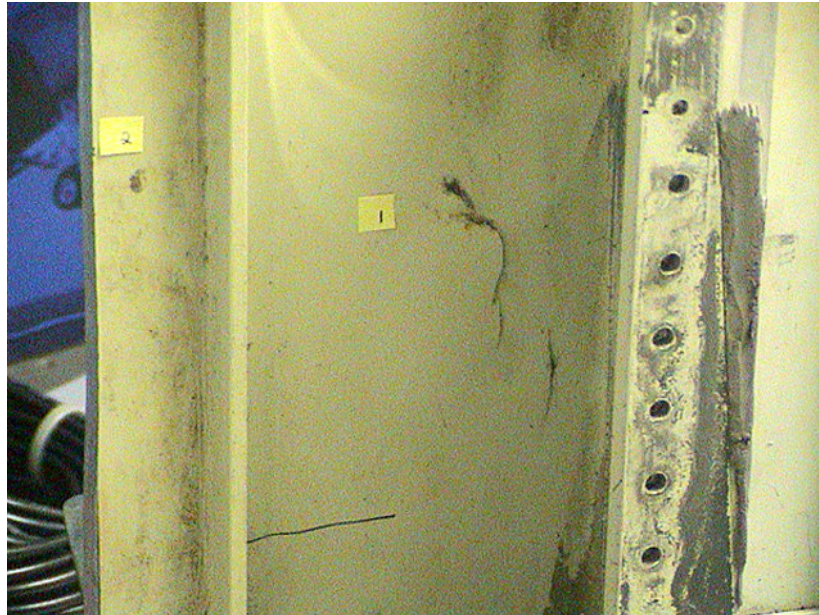
Visible and IR reflectance images of spot 1 and 2. The IR image shows the metal grain structure underneath the paint. Rework and corrosion can be seen in the IR.

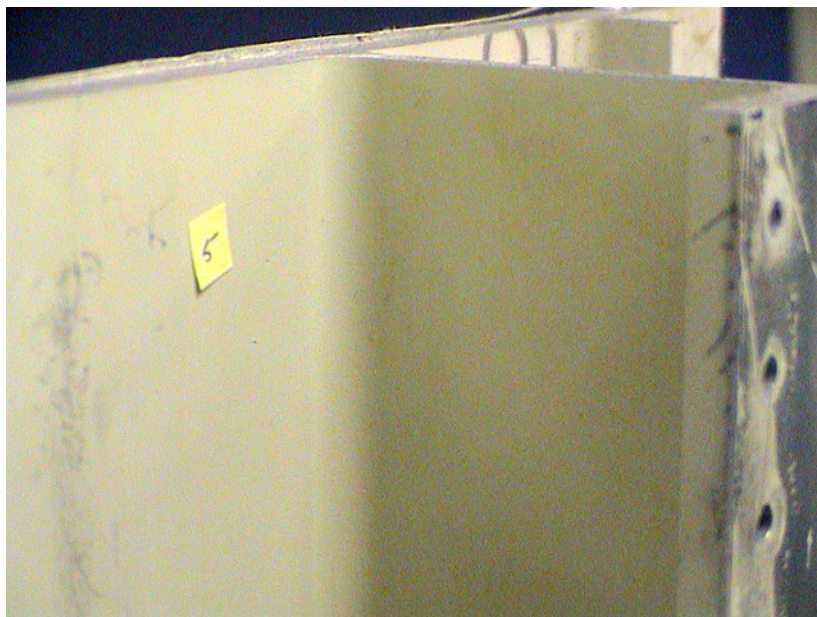
Visible and IR reflectance images of spot 5. After cleaning area with Naphtha, corrosion is clearly seen underneath the paint in the IR mode.
